# Rosebud County

## HIGH HAZARD LOCATION STUDY

Robert Peccia &  
Associates

December 1982

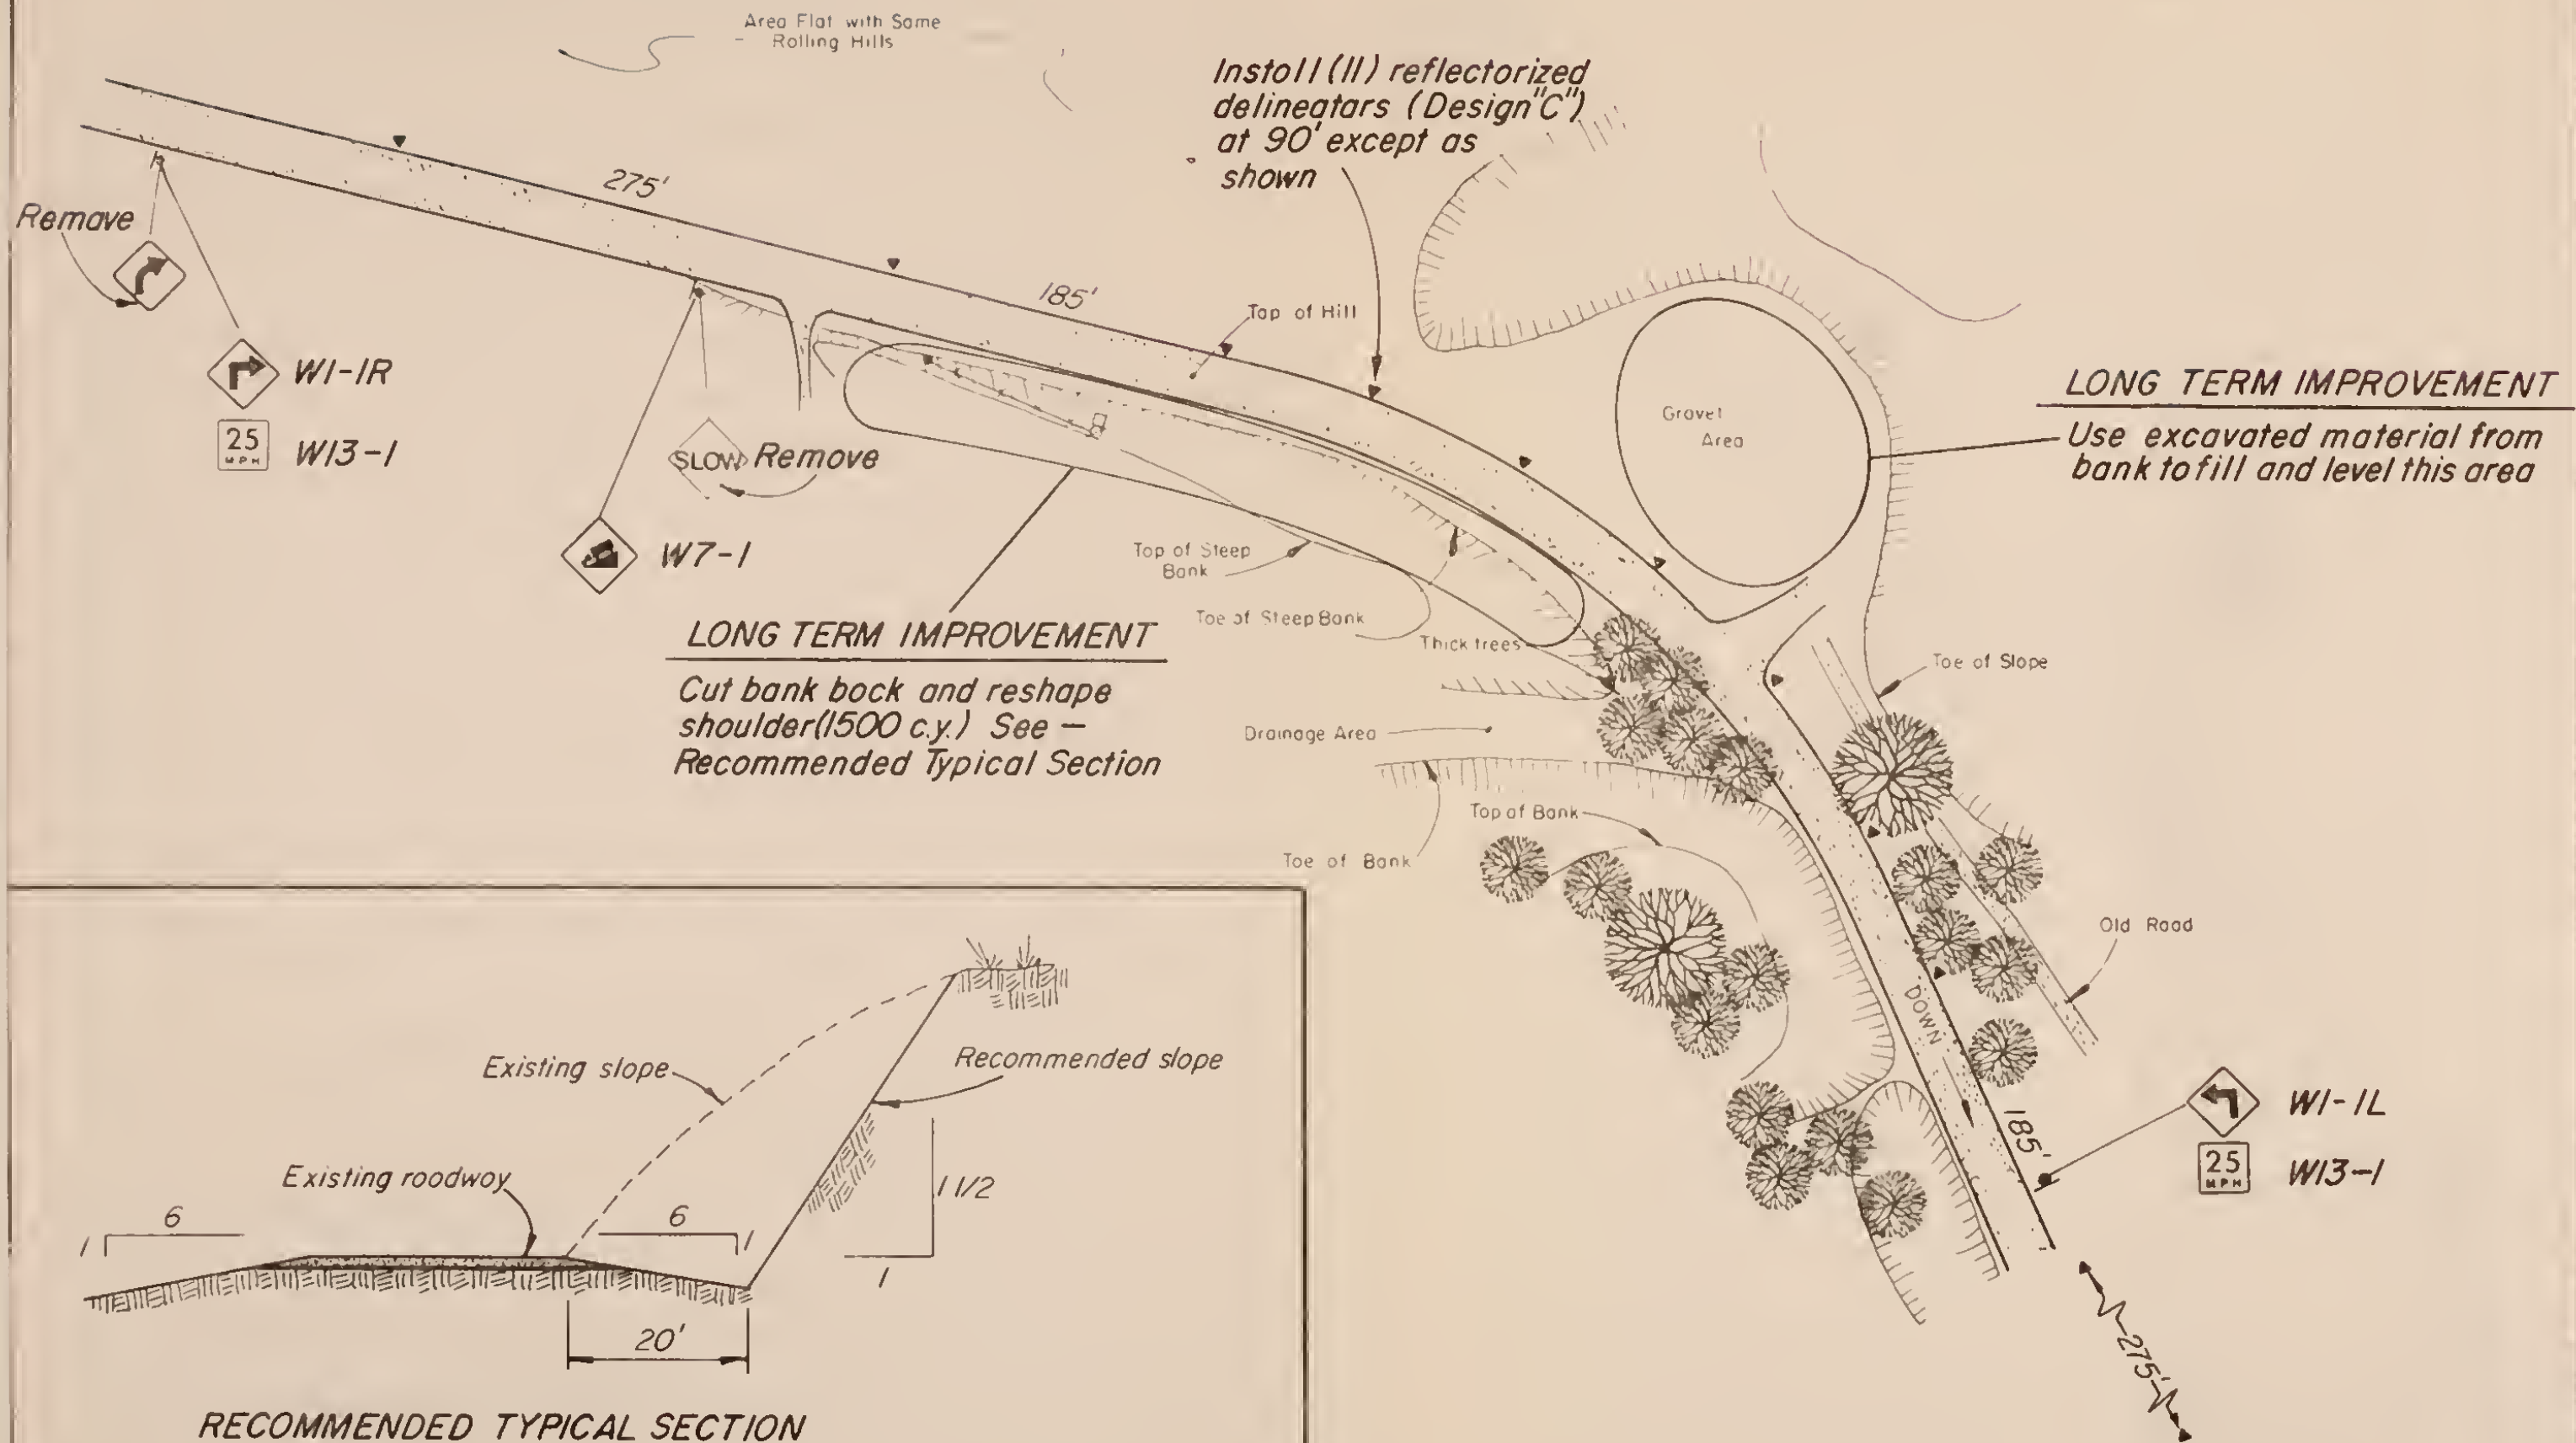
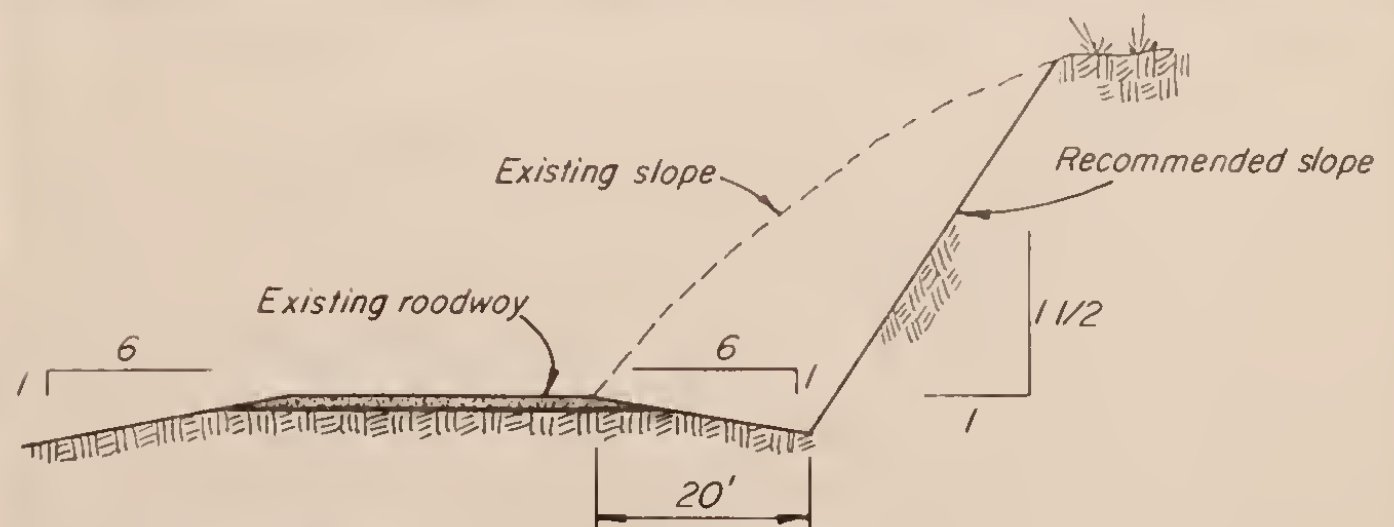
RECOMMENDED IMPROVEMENTS

RECOMMENDED TYPICAL SECTION

CARTERSVILLE ROAD-FORSYTH

Quantity	Unit	Item Description	Unit Price	Total Price
-	Lump Sum	Excavate Material from Bank and Reshape (1,500 cy); Deposit Material on Outside Shoulder and Reshape	-	\$4,500
Total Cost:				\$4,500

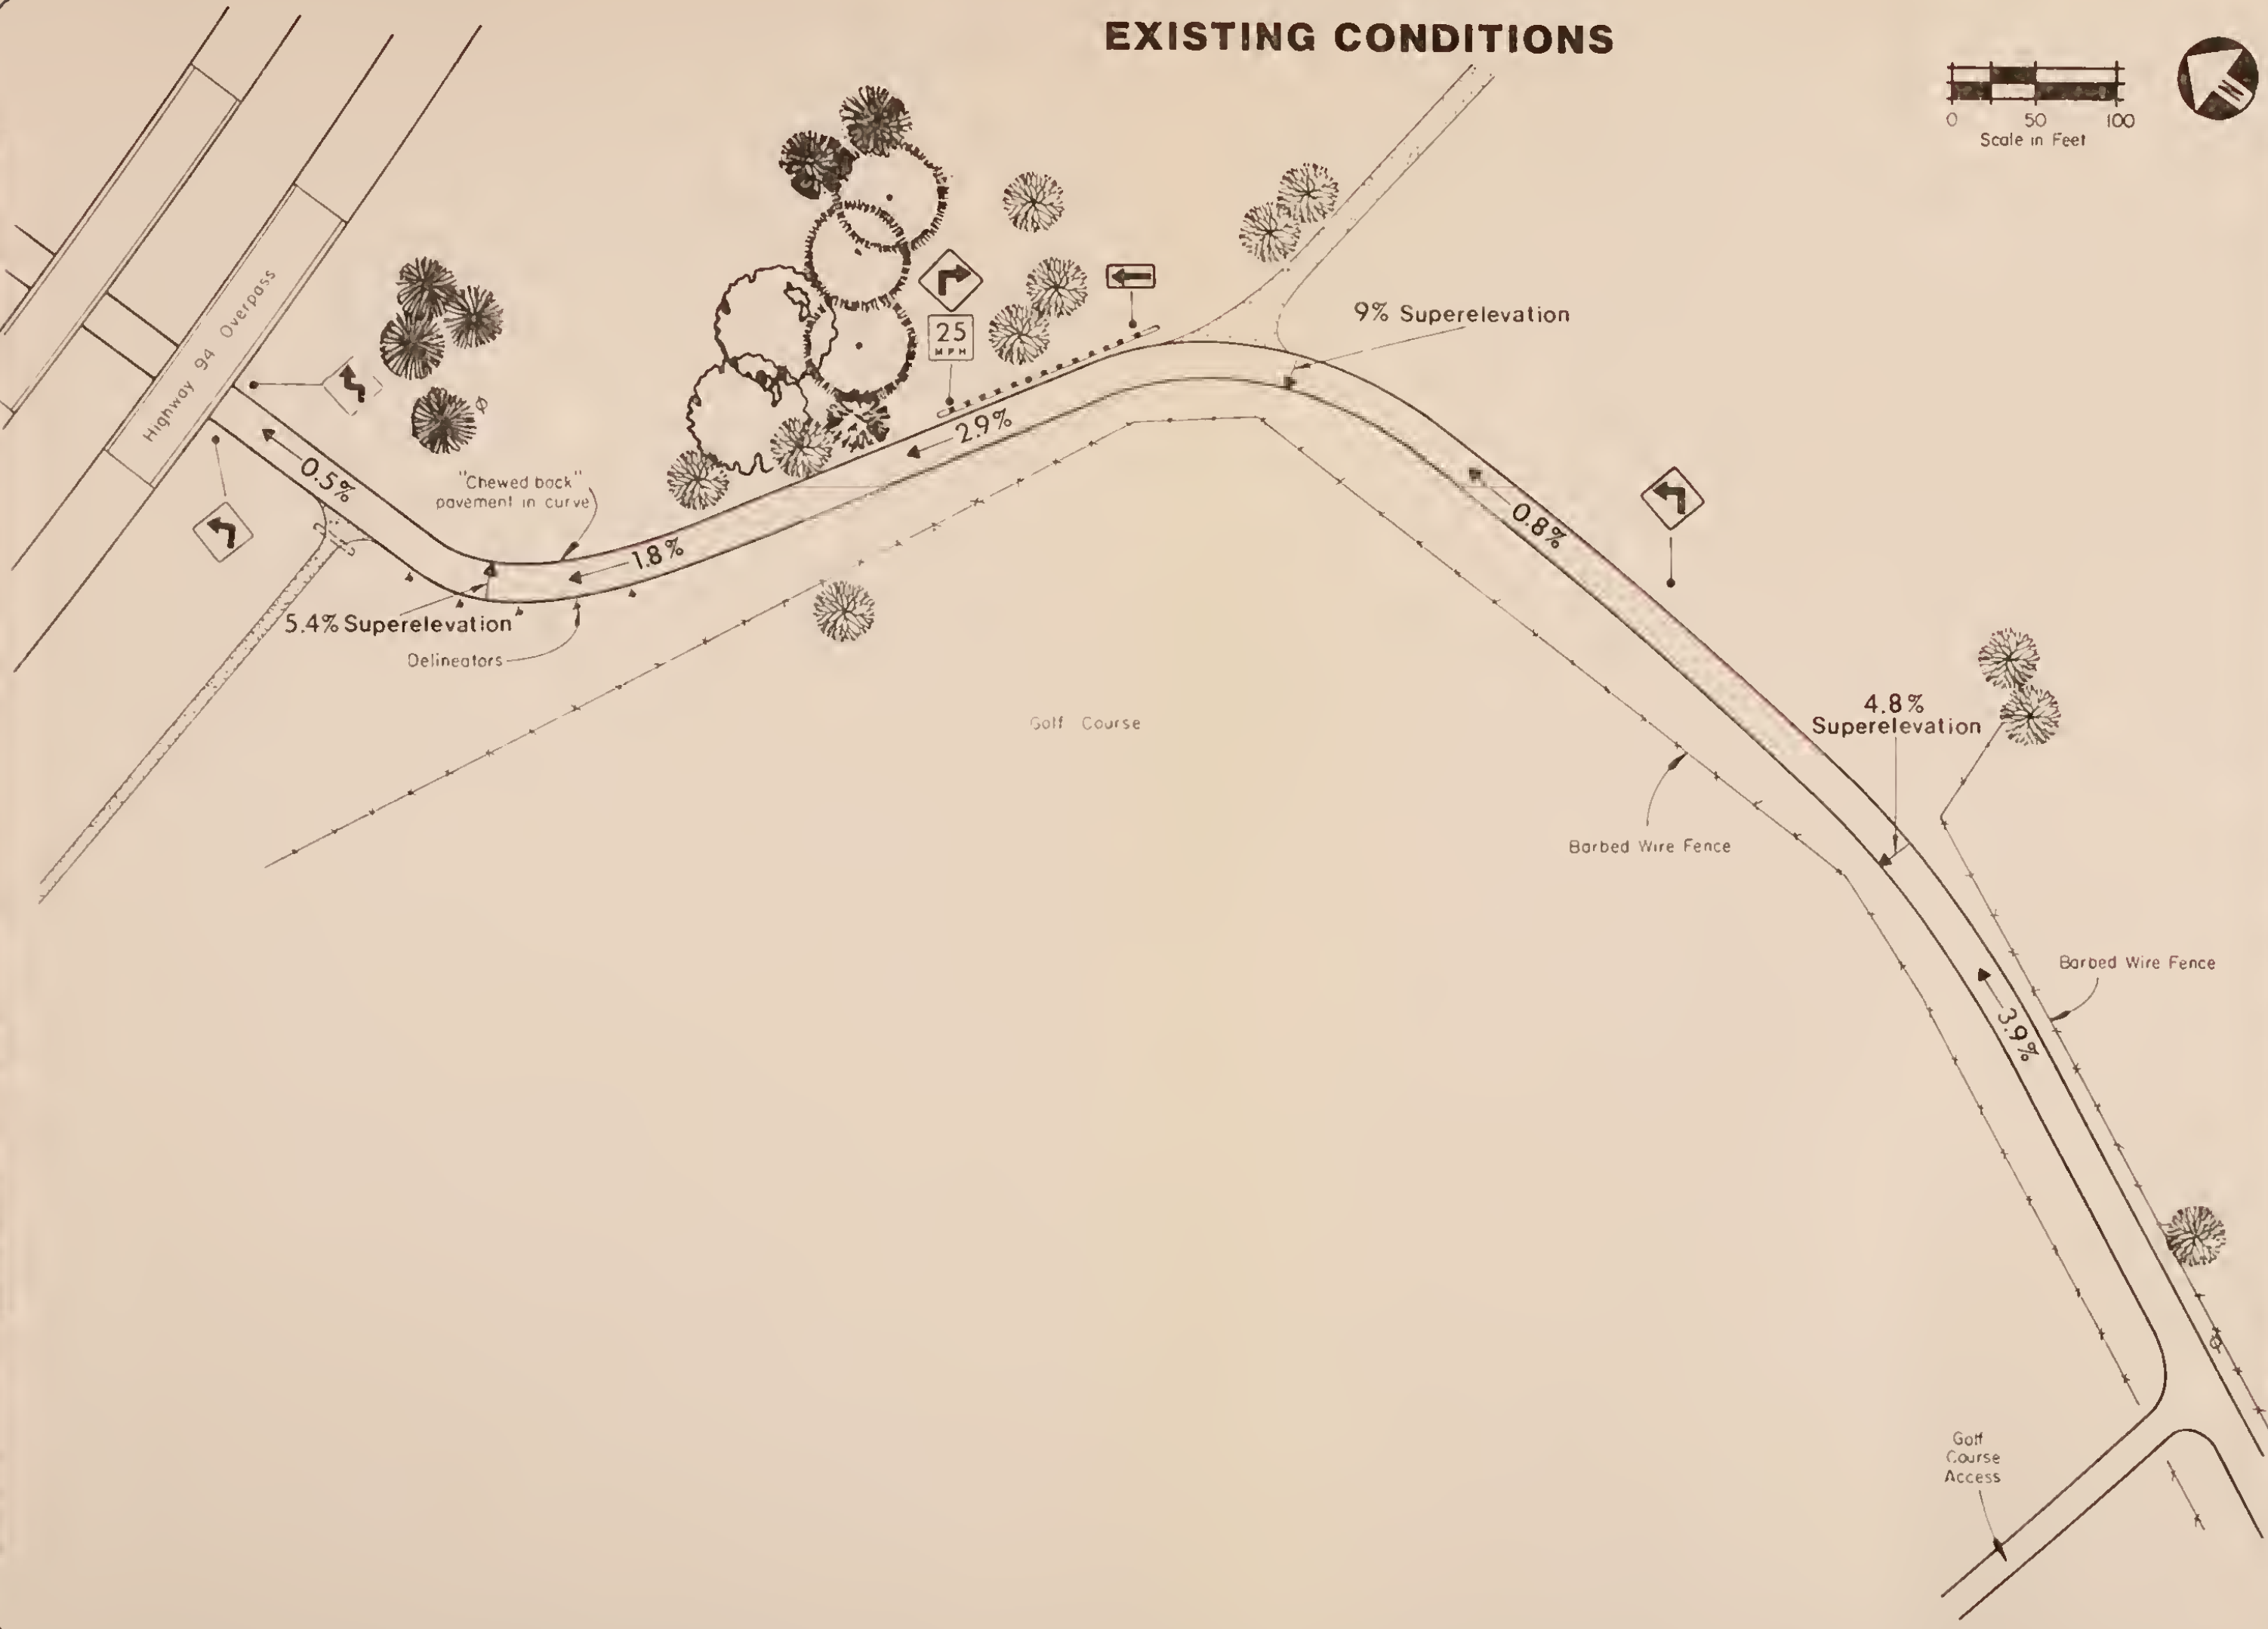
Site No. 2

SMITH CREEK ROAD

2. The accident history of this site indicates that most accidents involved northbound vehicles. It is therefore recommended that the curve delineation be improved for both approaches, with extra emphasis on the northbound lane. The existing directional arrow on the outside of the southernmost curve should be removed and a series of chevron warning signs (W1-8) in-

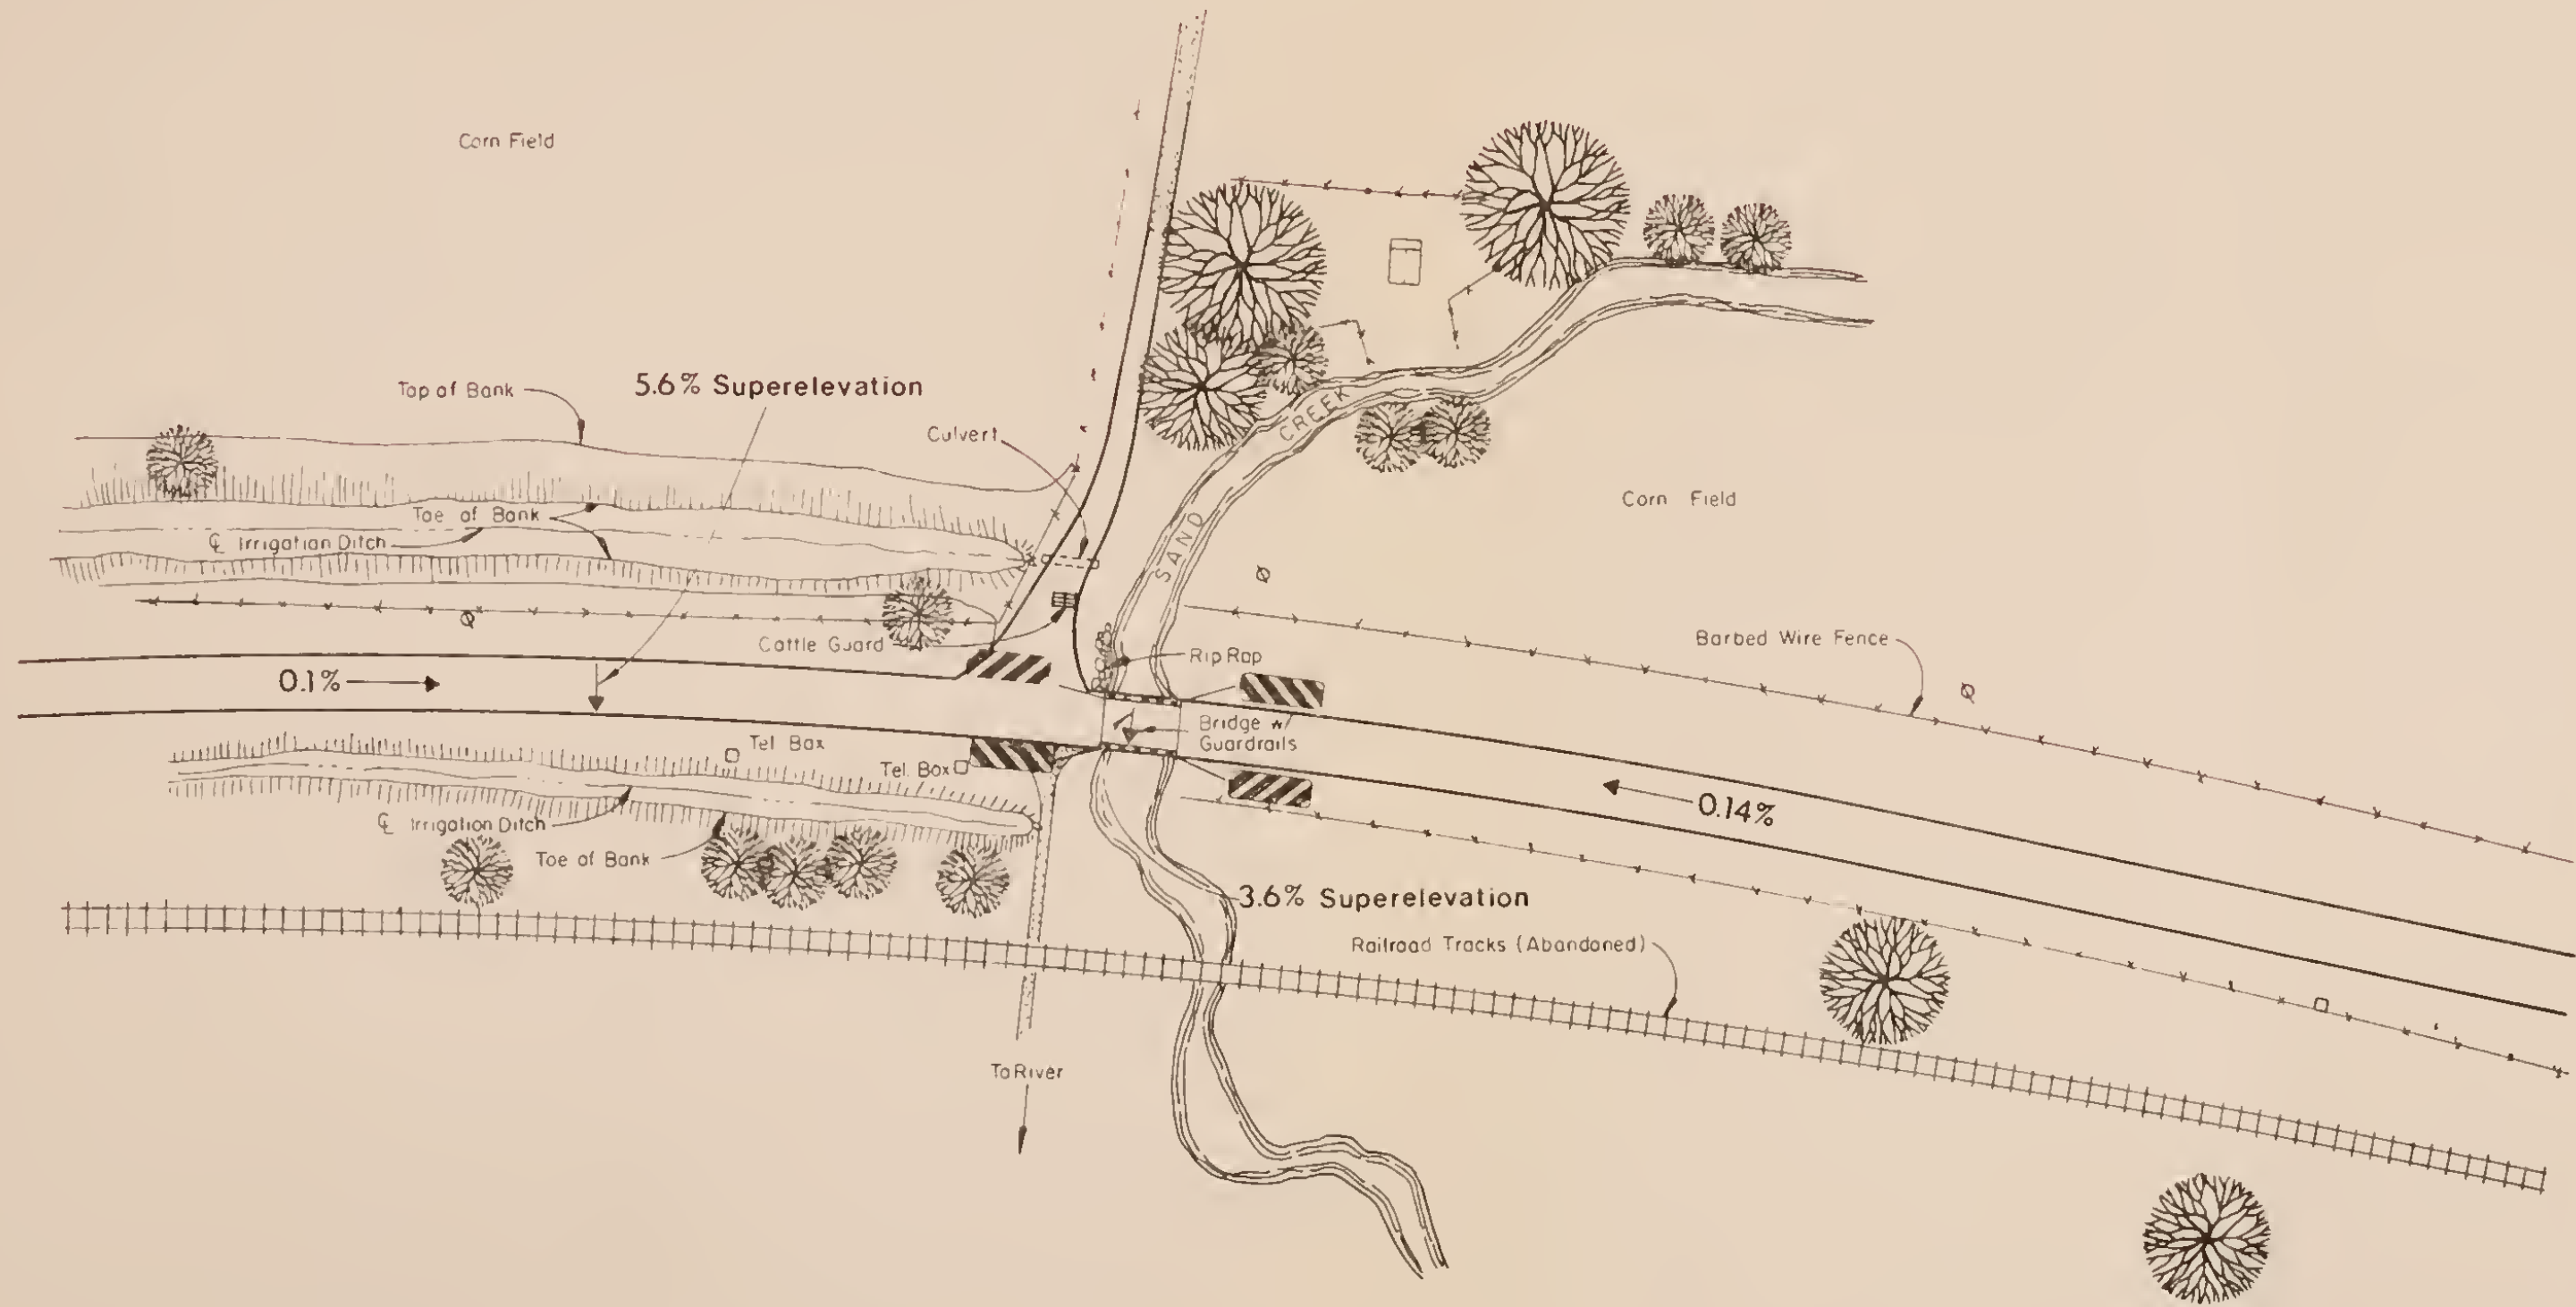
# Site No. 3

A total of three accidents were reported at this location during the study period. One of the accidents resulted in the deaths of two persons, and another was an injury accident resulting in an injury to the driver of the vehicle. The third accident involved a collision with a cow standing in the road. The fatal accident occurred when an eastbound vehicle struck the railing on the Sand Creek Bridge and flipped end over end. Another accident, which occurred in 1978, also involved a vehicle striking the bridge railing. All three of the reported accidents occurred at night during clear

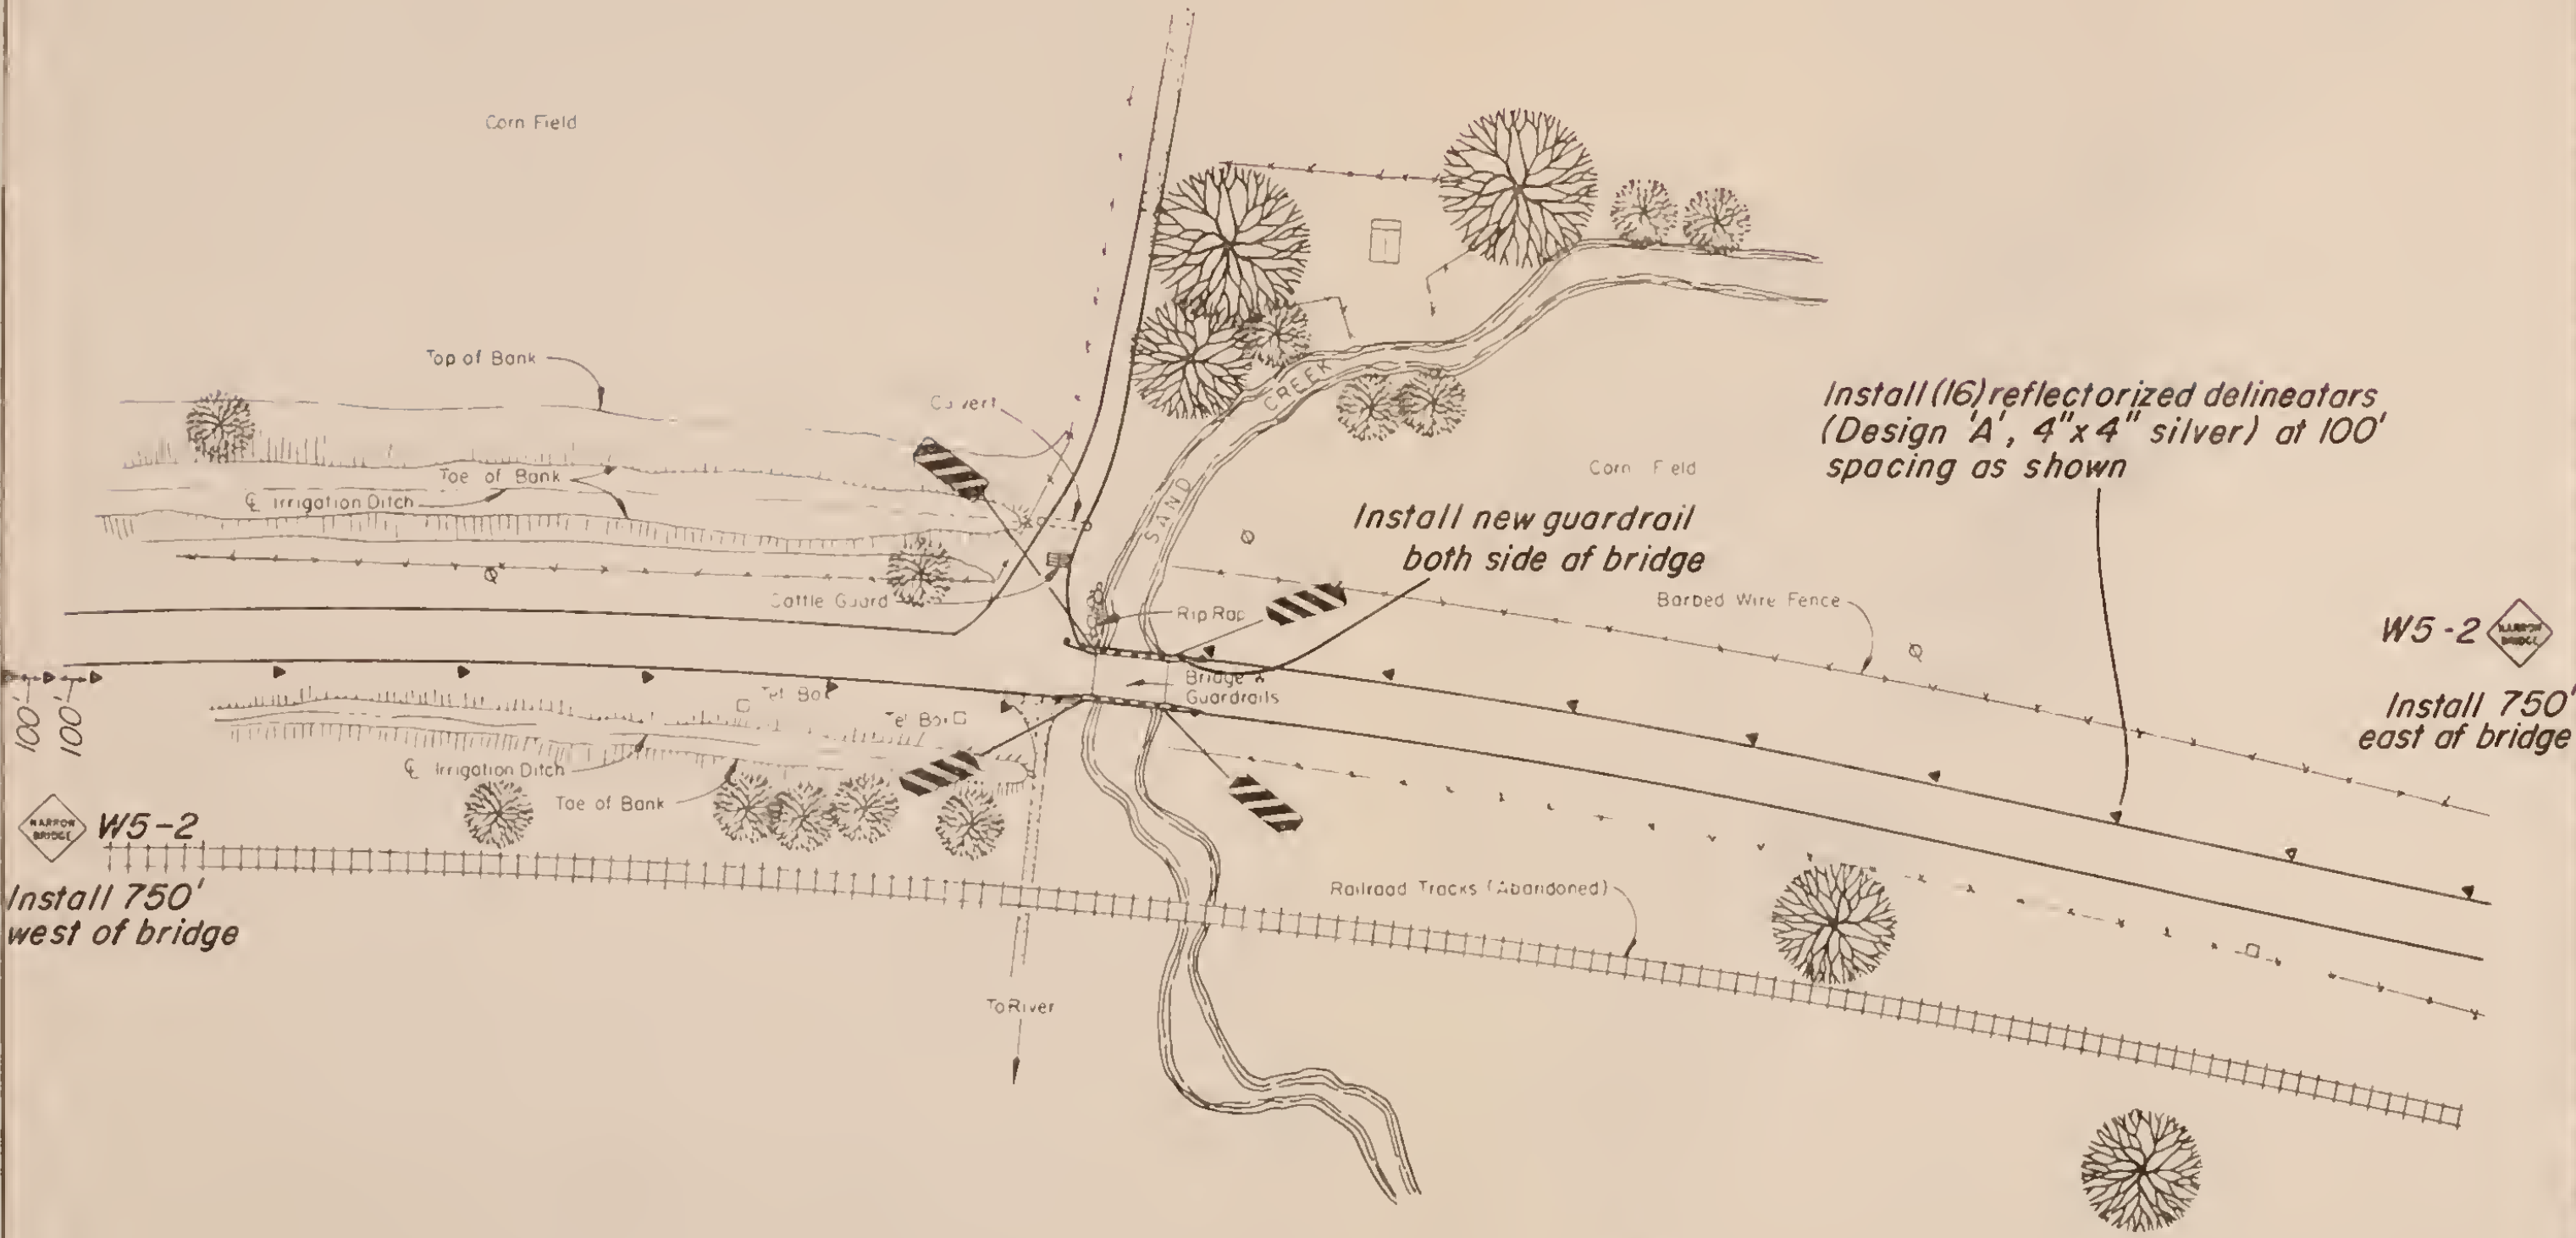
Site No. 3

RECOMMENDED IMPROVEMENTS

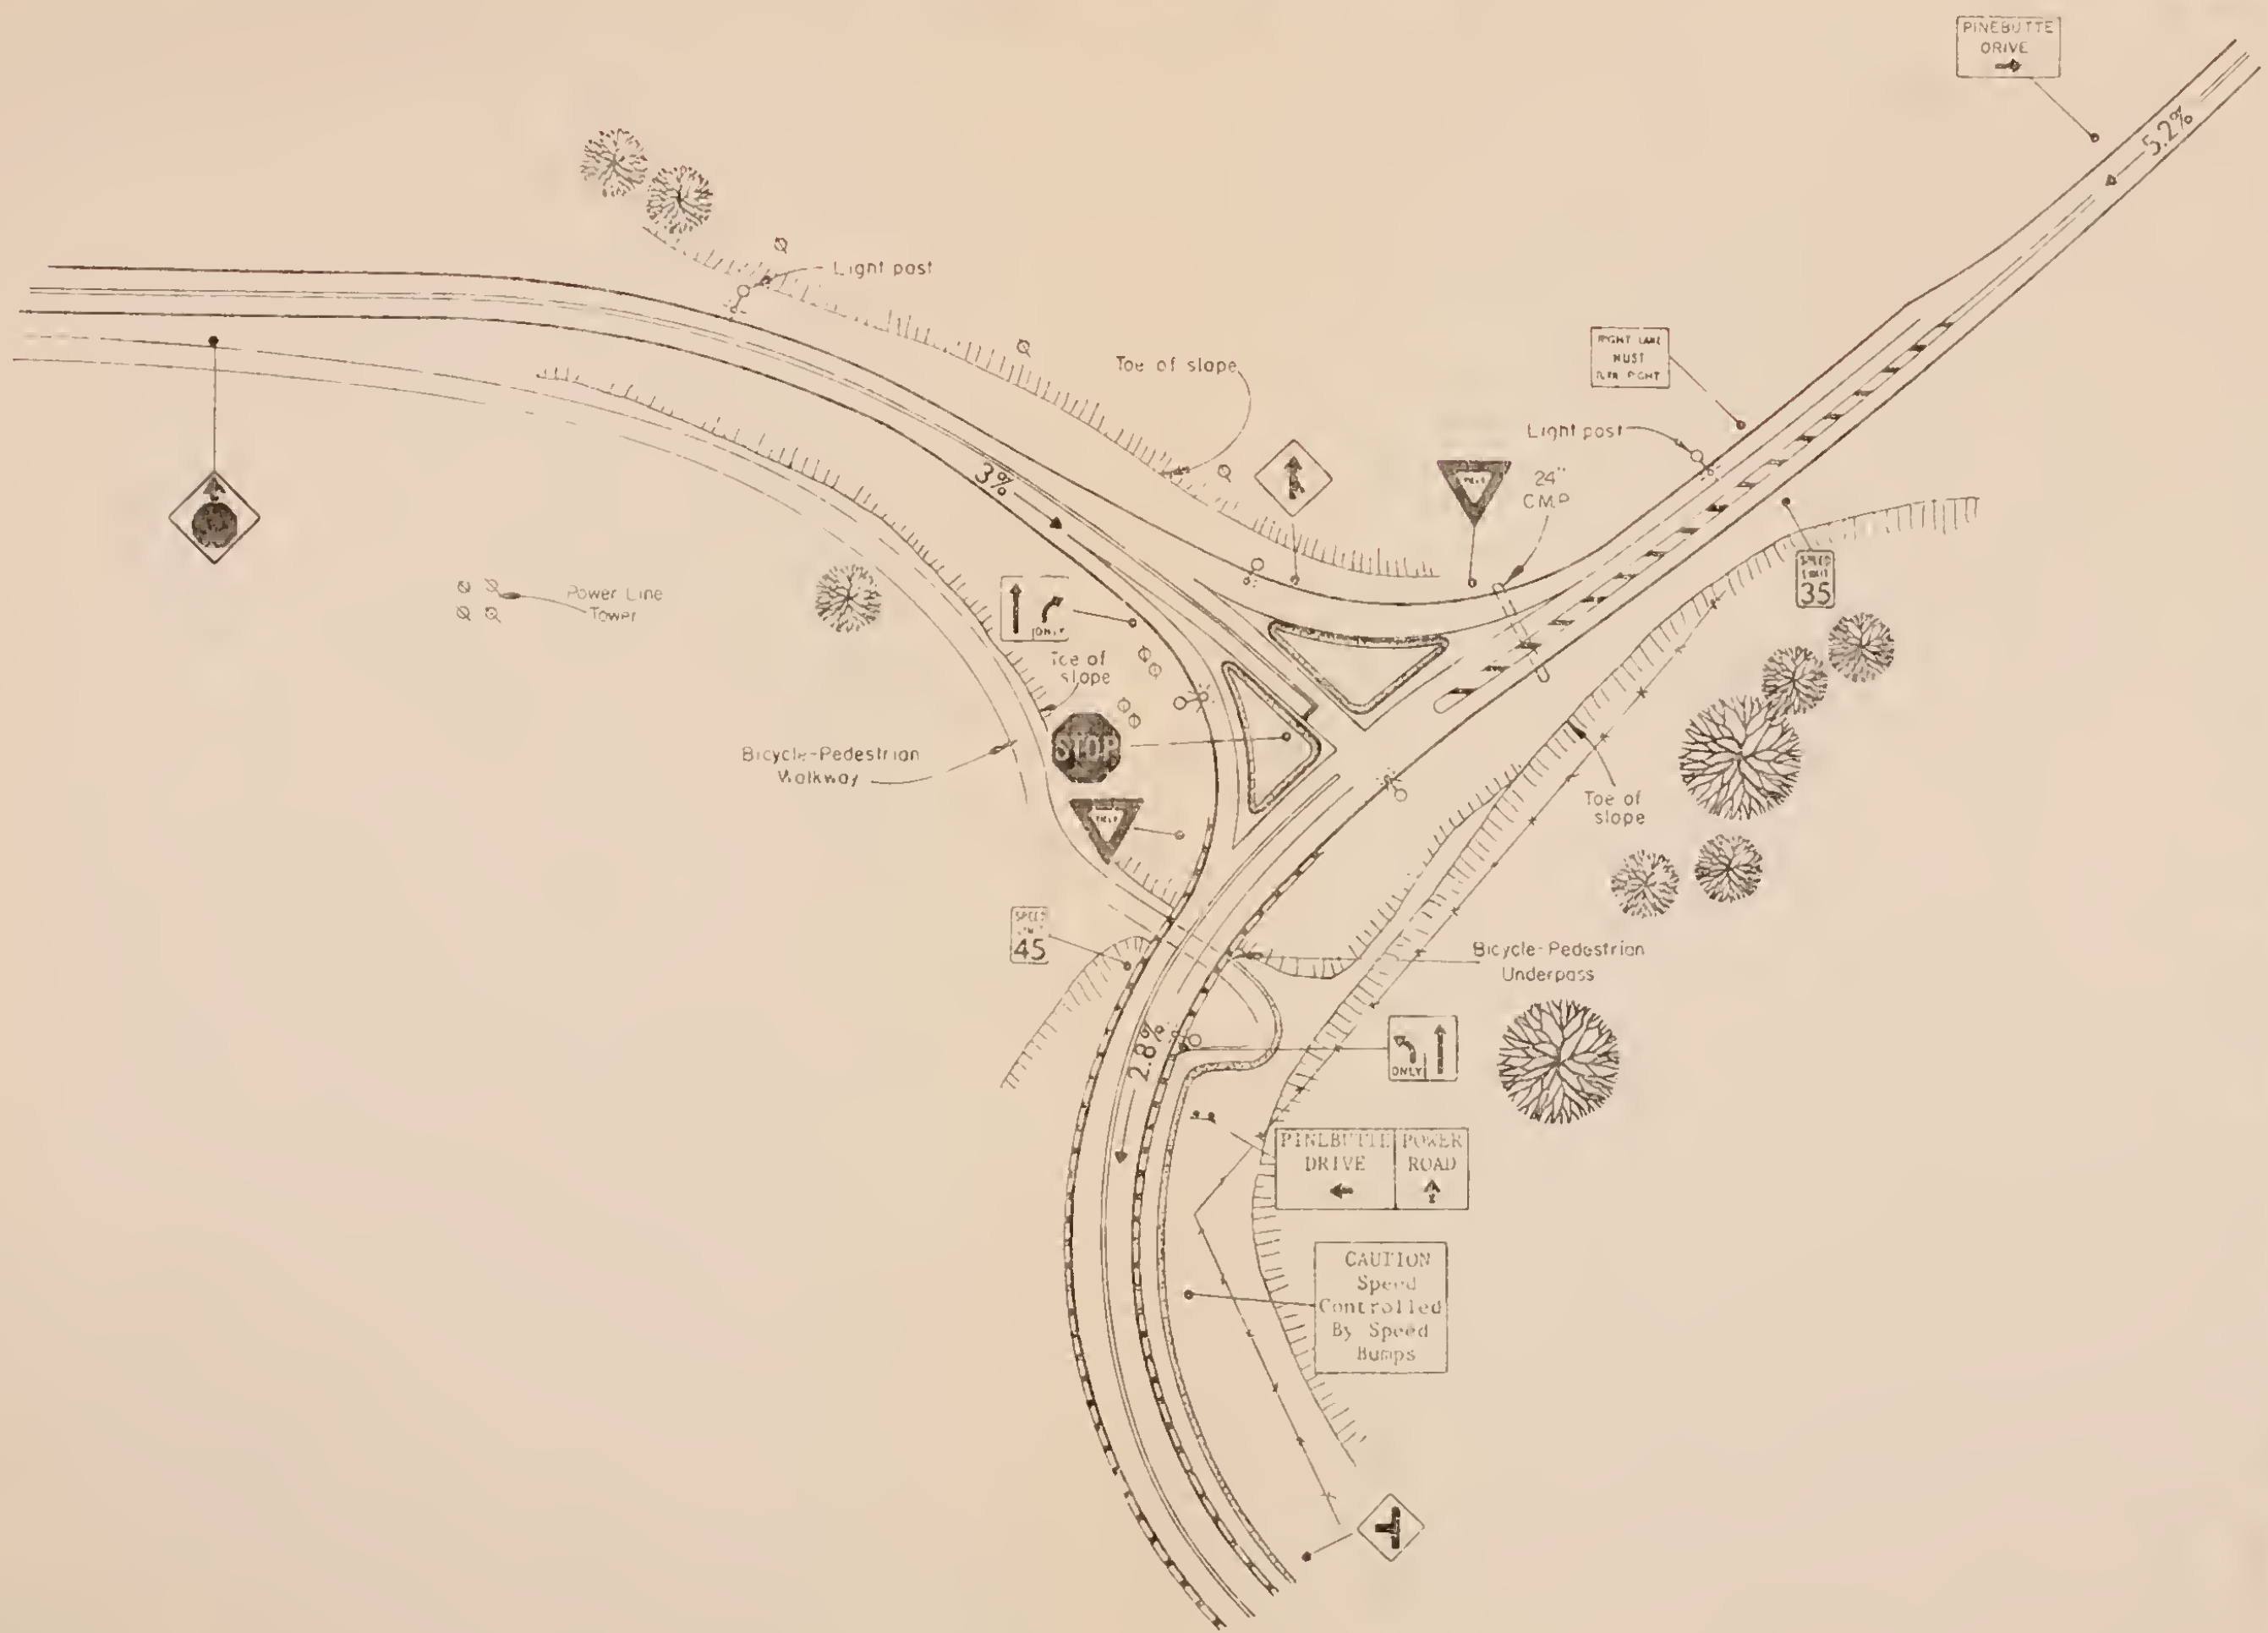
**Site No. 4**

Signing on the east approach to the intersection (Power Road) consists of a "Merge" sign (W4-1) in the merge lane with Pine Butte Drive; a "Yield" sign at the turn; a "Mandatory Turn" sign (R3-7) for traffic in the right lane; and an informational street sign located approximately 500 feet east of the intersection.

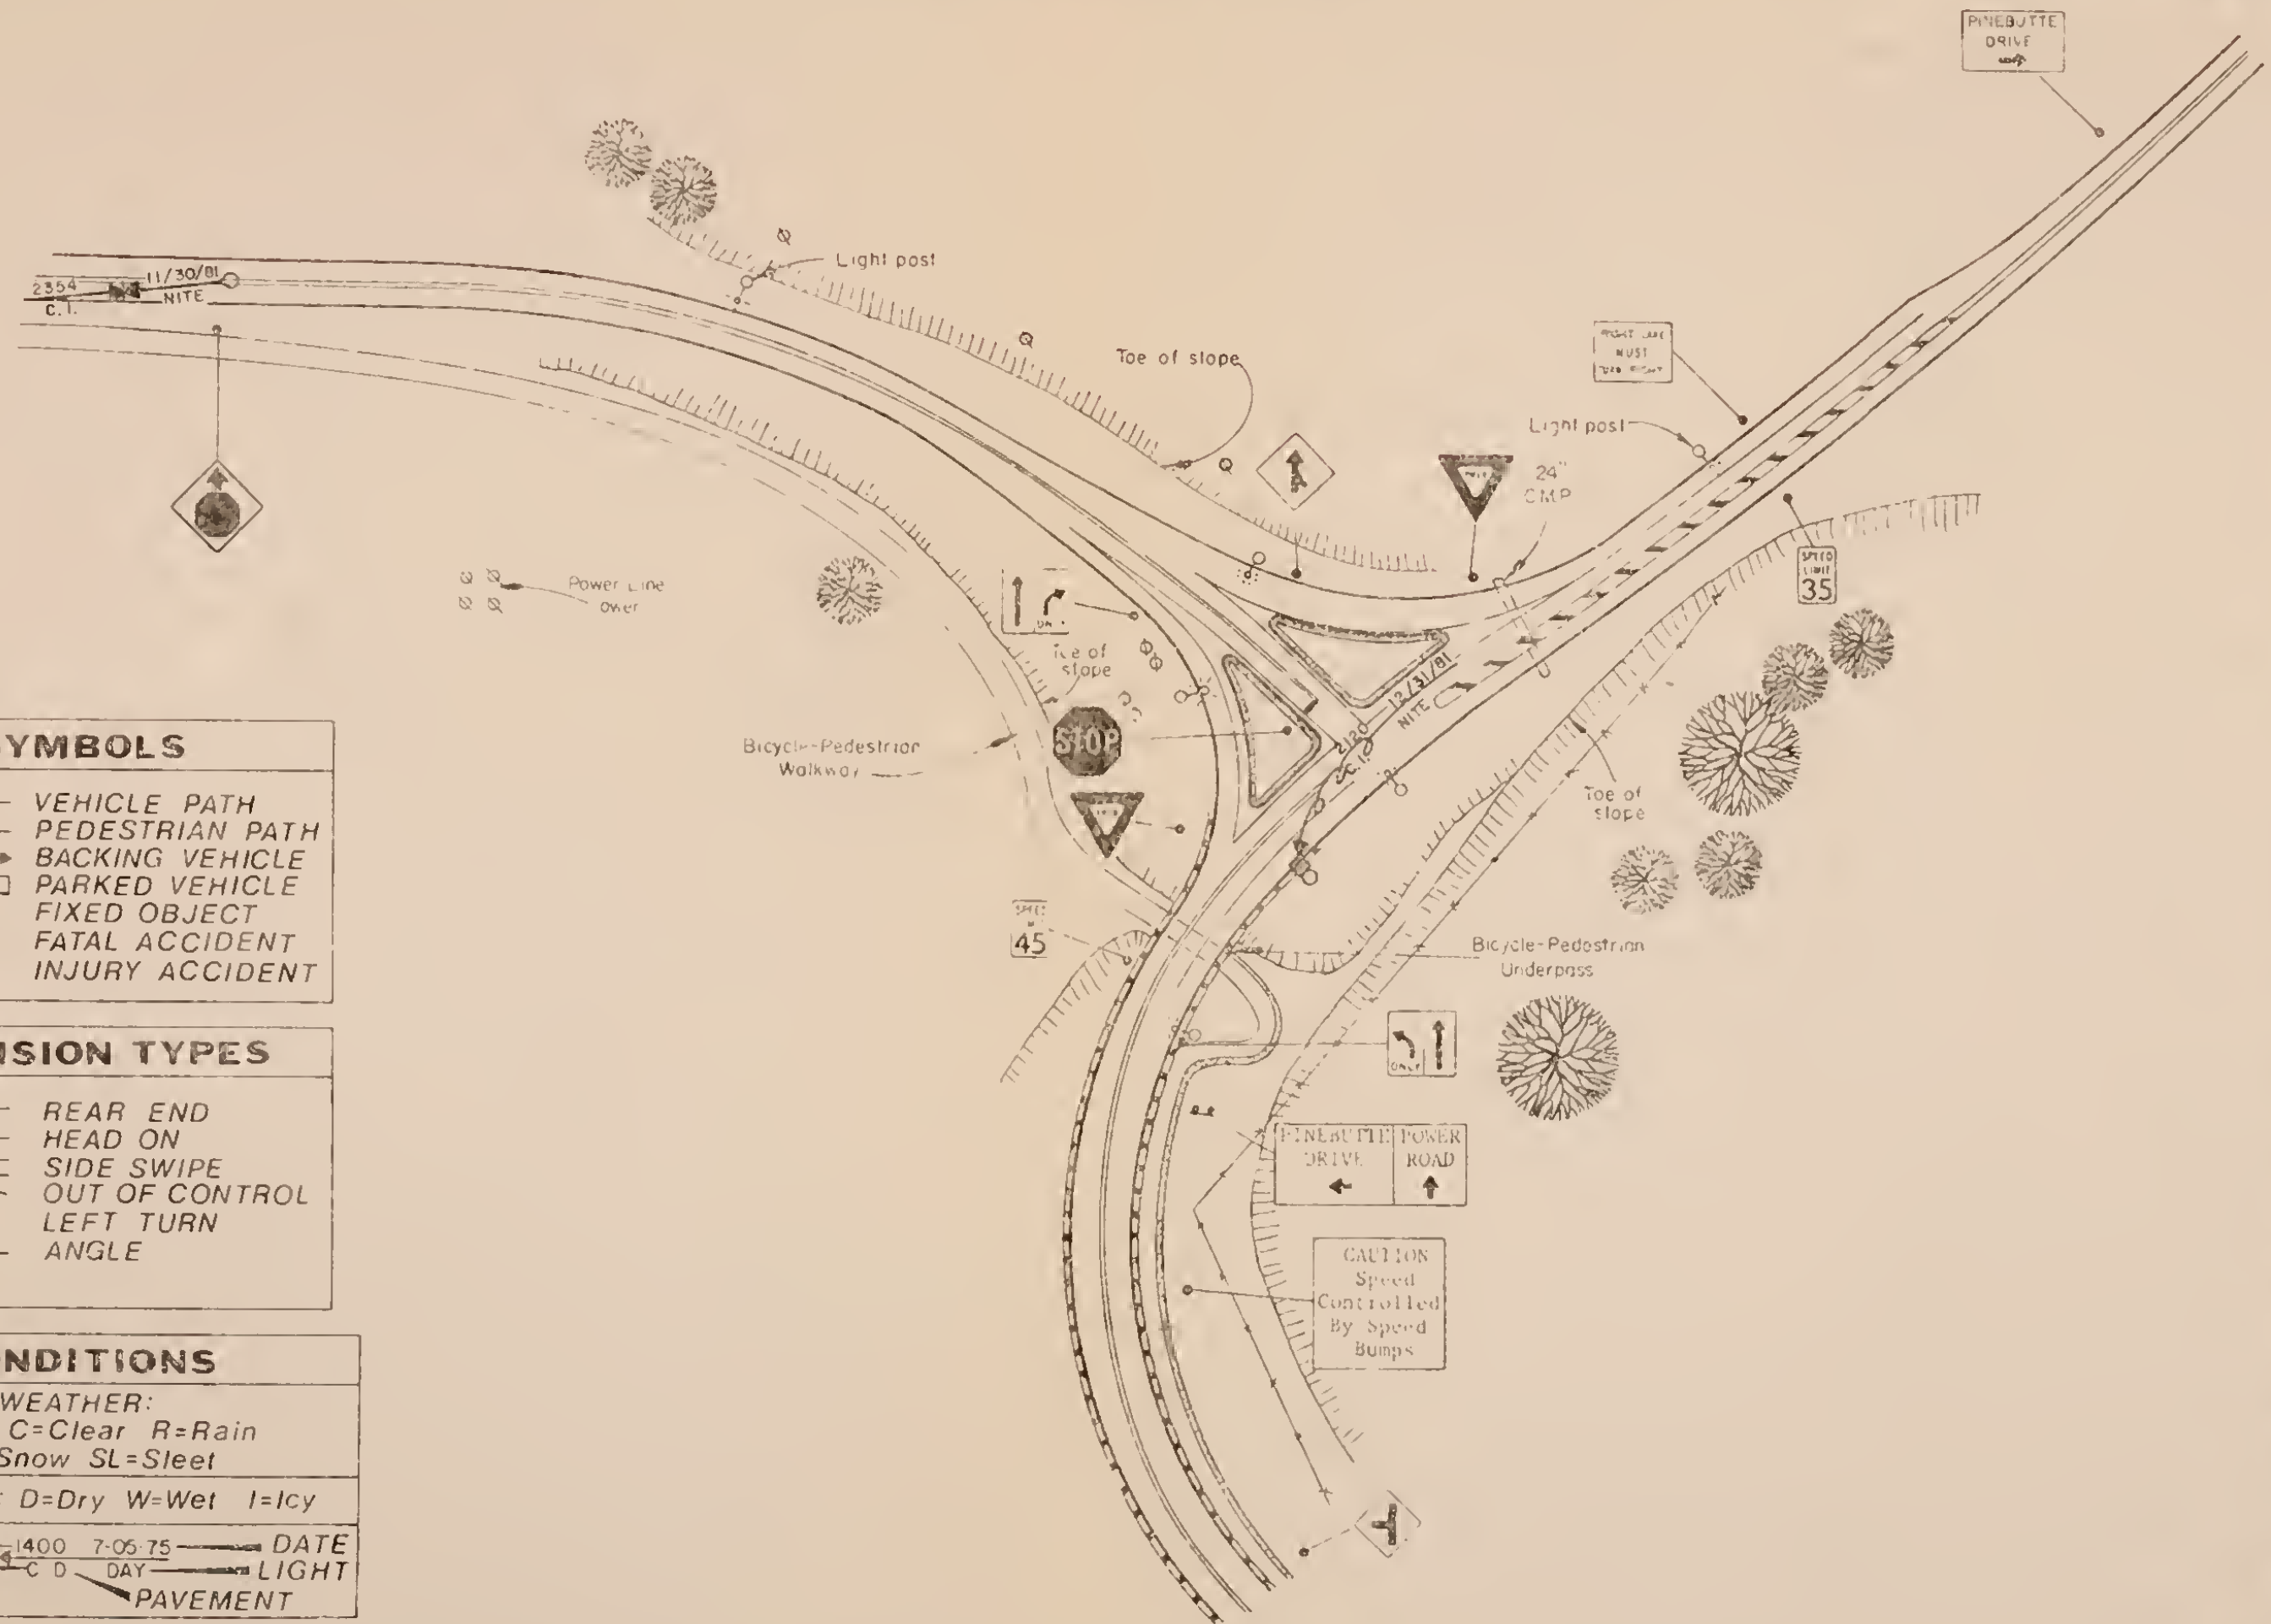
Site no. 4

Reconstruction at Site #4 in 1980 significantly changed the character of this site. Due to the required consistency in analysis procedures, however, it is necessary to include the years from 1978 through 1980 even though site characteristics were completely different. In order to obtain more insight into site deficiencies or driver tendencies, 1982 reported accidents were revised in the analysis. Three accidents have been reported to date during 1982 at
